**DEPARTMENT OF TRANSPORTATION****DIVISION OF ENGINEERING SERVICES**

Contract #: 04-0120F4Cty: SF/ALA Rte: 80 PM: 13.2/13.9File #: 1.28**WELDING INSPECTION REPORT****Resident Engineer:** Casey, William**Address:** 333 Burma Road**City:** Oakland, CA 94607**Report No:** WIR-027134**Date Inspected:** 02-Feb-2012**Project Name:** SAS Superstructure**OSM Arrival Time:** 700**Prime Contractor:** American Bridge/Fluor Enterprises, a JV**OSM Departure Time:** 1730**Contractor:** American Bridge/Fluor Enterprises, a JV**Location:** Job Site**CWI Name:** Steve Jensen**CWI Present:** Yes No**Inspected CWI report:** Yes No N/A**Rod Oven in Use:** Yes No N/A**Electrode to specification:** Yes No N/A**Weld Procedures Followed:** Yes No N/A**Qualified Welders:** Yes No N/A**Verified Joint Fit-up:** Yes No N/A**Approved Drawings:** Yes No N/A**Approved WPS:** Yes No N/A**Delayed / Cancelled:** Yes No N/A**Bridge No:** 34-0006**Component:** SAS OBG**Summary of Items Observed:**

# WELDING INSPECTION REPORT

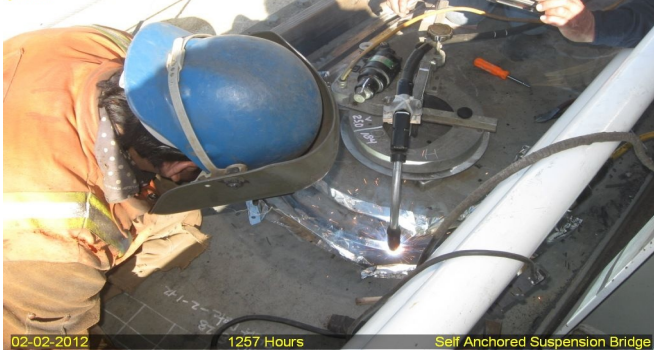
At OBG 5W-PP29-W2 deck access hole, (rft) plate to top deck plate outside, ABF welder Wai Kitlai was observed performing 1G Flux Cored Arc Welding (FCAW) partially welding fill pass to cover pass on butt joint.

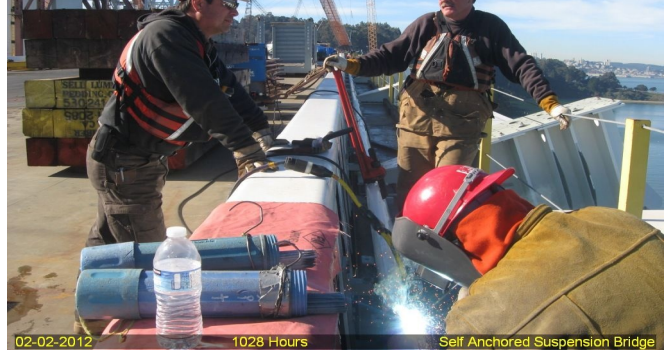
At panel point location PP53 of OBG grid line W2, FW Spencer welder Damian Llanos was observed performing 6G Shielded Metal Arc Welding (SMAW) welding root pass to cover pass on 2 1/2" and 4" diameter pipe field splice butt joints.

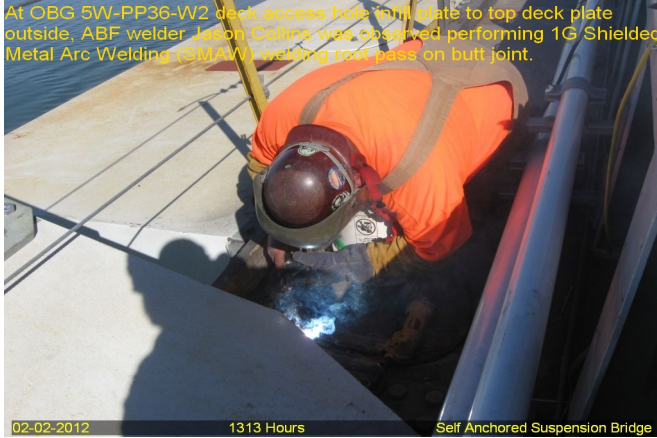
At OBG 5W-PP36-W2 deck access hole form plate to top deck plate outside, ABF welder Jason Collins was observed performing 1G Shielded Metal Arc Welding (SMAW) welding root pass on butt joint.
